# Manhole Inspection Summary

Manhole # S17QQ\_004MH

Insp Date: **4/8/09 3:01 PM**

**Location** Address: **REAR OF 2706 REISTERSTOWN RD** Cross Street: **LIBERTY HEIGHTS**

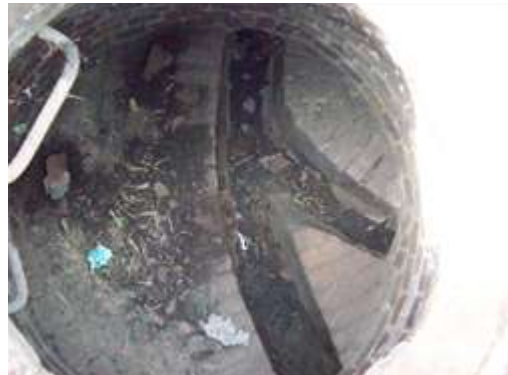
Top View

DEBRIS IN CHANNEL AND ON BENCH

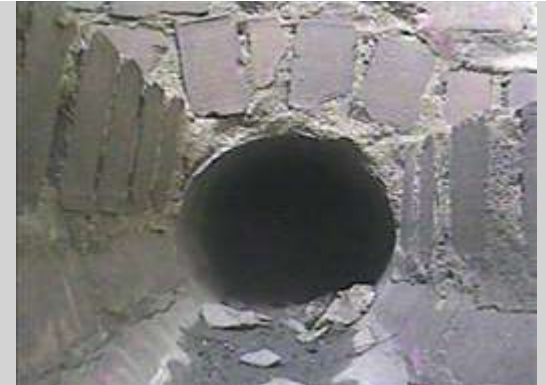
12 O'Clock Outflow

8 in. Circular Gravity Sewer  
Pipe Out @ 12 O'Clock

Pipe Height: (in.) Direct  
Pipe Material: **Clay** ☐ Pipe Lined  
Invert Depth: **4.90** (ft.) Flow Characteristics: **Slow**  
Deposits: ☒ None ☐ Mud ☐ Sludge ☐ **Debris** ☐ Grease  
Silt Depth: (in.) Deposits Extent:  
Infiltration: **None** Pipe Seal Cond: **Sound**

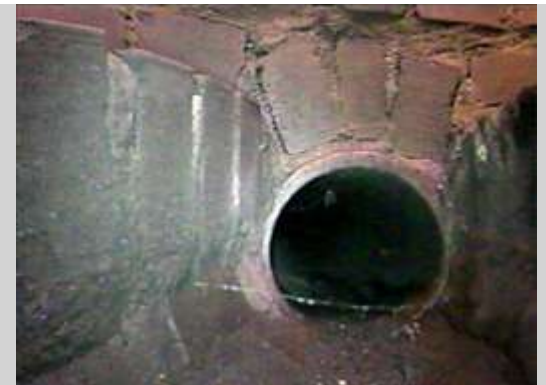
4 O'Clock Inflow

6 in. Circular Gravity Sewer  
Pipe In @ 4 O'Clock

Pipe Height: (in.) Direct  
Pipe Material: **Clay** ☐ Pipe Lined  
Invert Depth: **4.85** (ft.) Flow Characteristics: **Slow**  
Deposits: ☒ None ☐ Mud ☐ Sludge ☐ **Debris** ☐ Grease  
Silt Depth: (in.) Deposits Extent:  
Infiltration: **None** Pipe Seal Cond: **Sound**

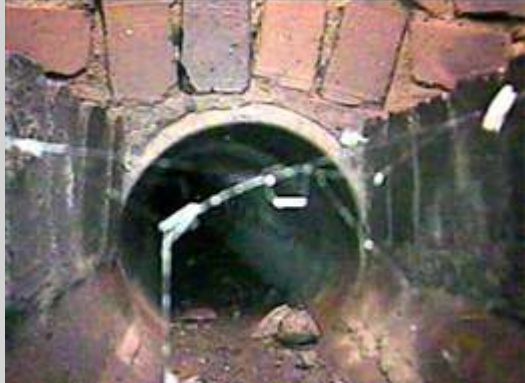
5 O'Clock Inflow

8 in. Circular Gravity Sewer  
Pipe In @ 5 O'Clock

Deposits: ☐ None ☐ Mud ☐ Sludge ☒ **Debris** ☐ Grease

Silt Depth: **0.5** (in.) Deposits Extent: **Light**
